Re: **Wines of the San Juan; SIC 2084; MSGP Compliance Evaluation Inspection; NPDES #  
NMU001963; April 4, 2018**

## NPDES Compliance Inspection Report

**Wines of the San Juan**  
**NMU001963**  
**April 4, 2018**

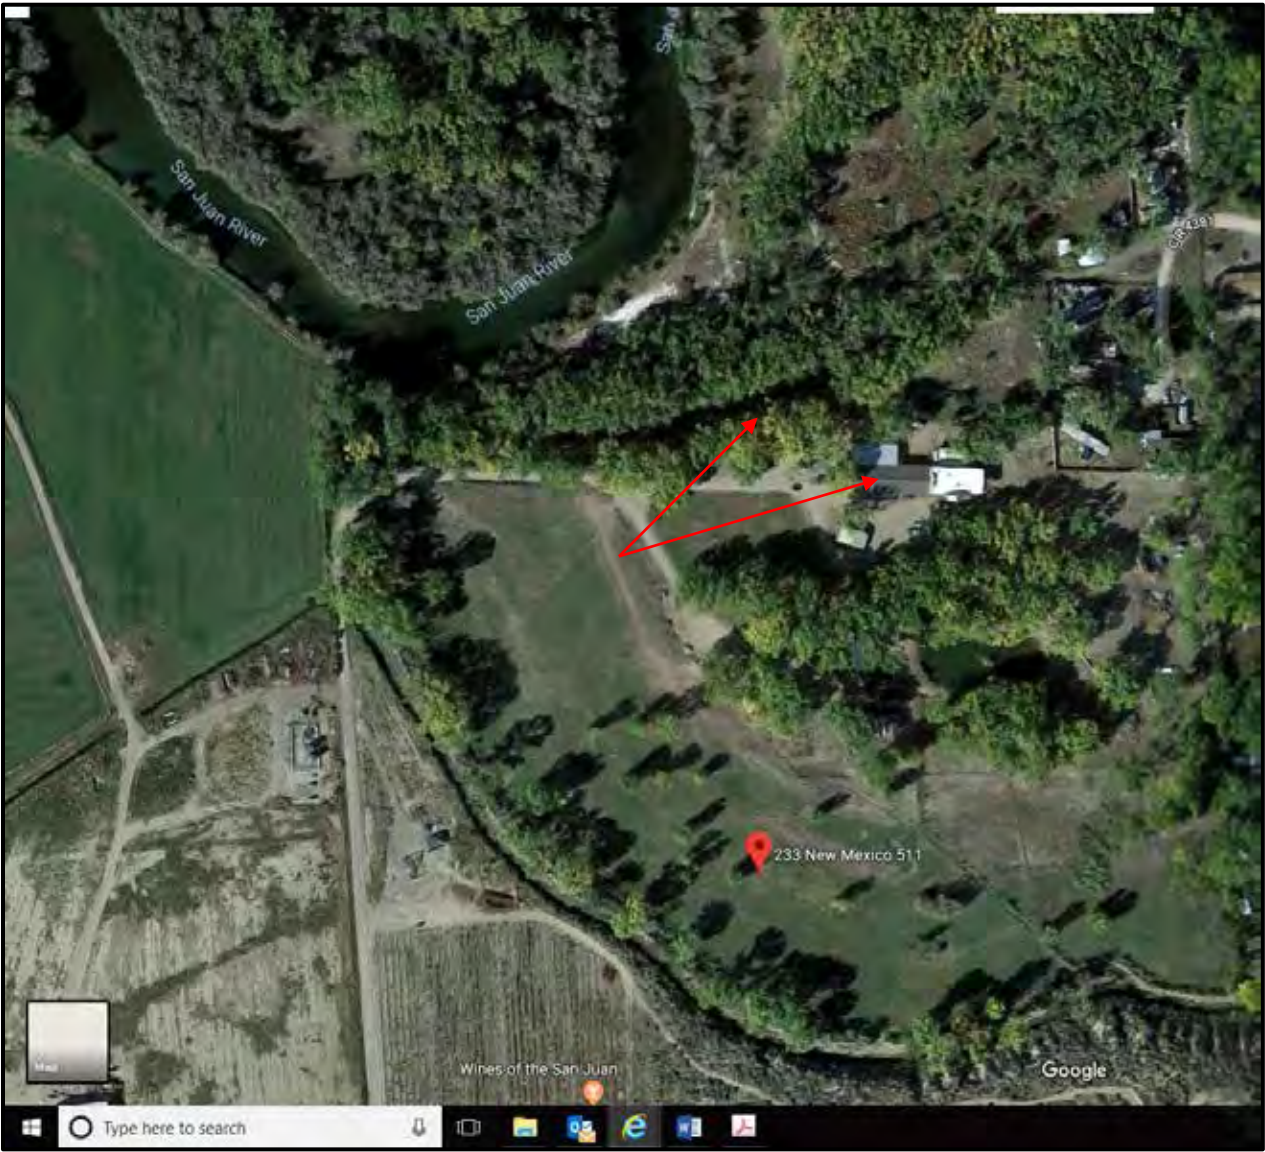
NMED/SWQB  
Site Overview

Google Maps	
City/County: Blanco/San Juan		
Location: 233 Highway 511 @Turley, Blanco, New Mexico 87412		
Subject: Wines of the San Juan facility. Arrows point to the processing building and discharge outfall.

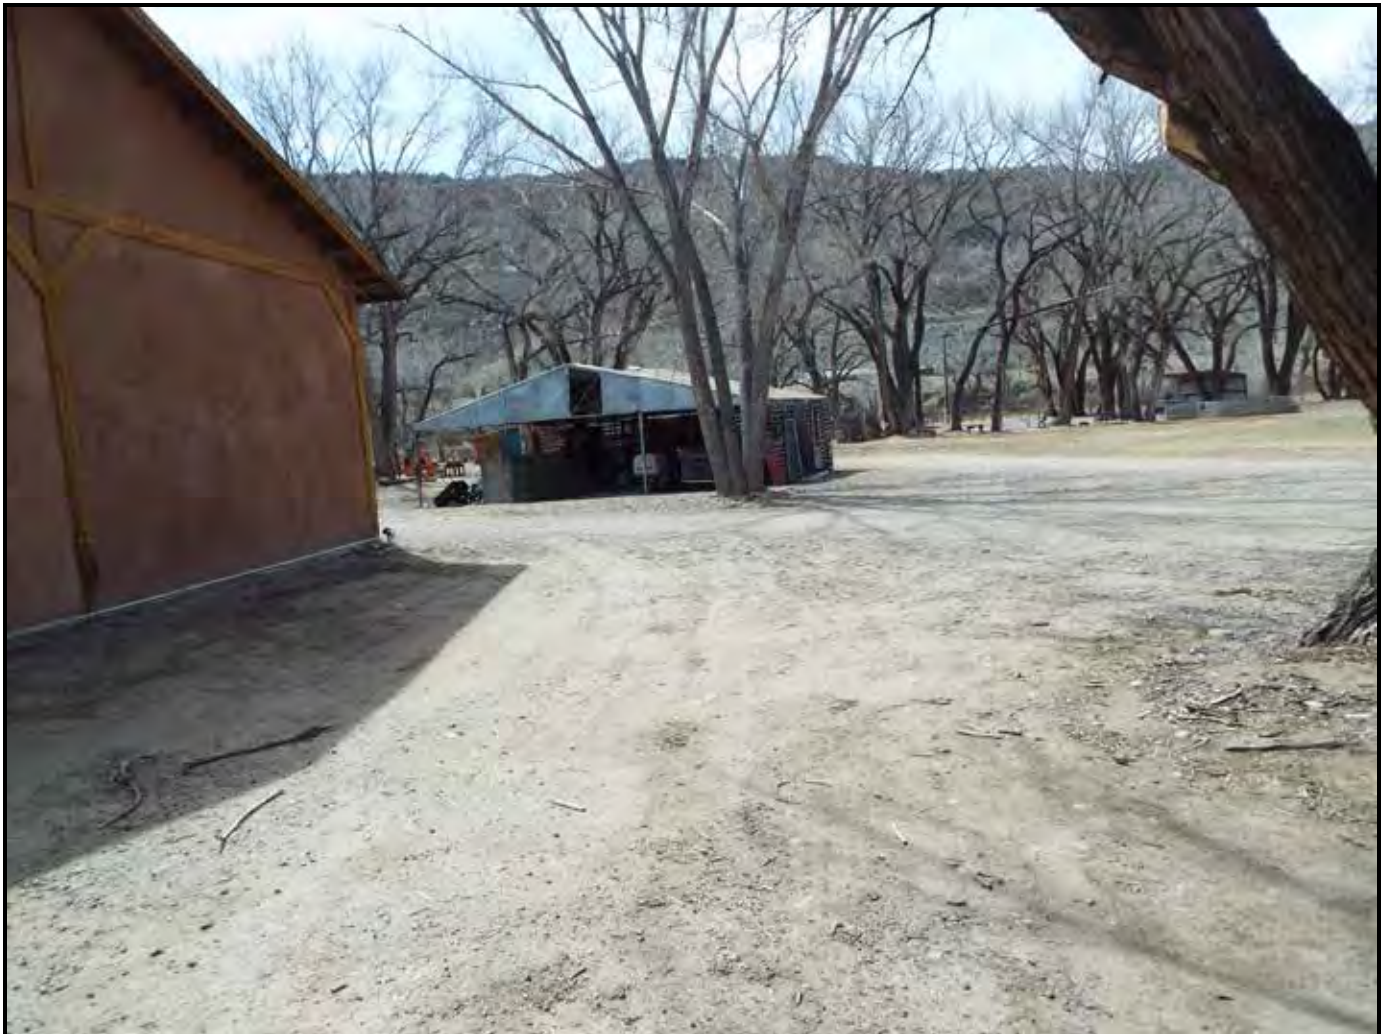
Photo # 1

Photographer: Daniel Valenta	Date: April 4, 2018	Time: 1132 hours
City/County: Blanco/San Juan		
Location: 233 Highway 511, Blanco, New Mexico 87412		
Subject: Wines of the San Juan facility site is fairly level,

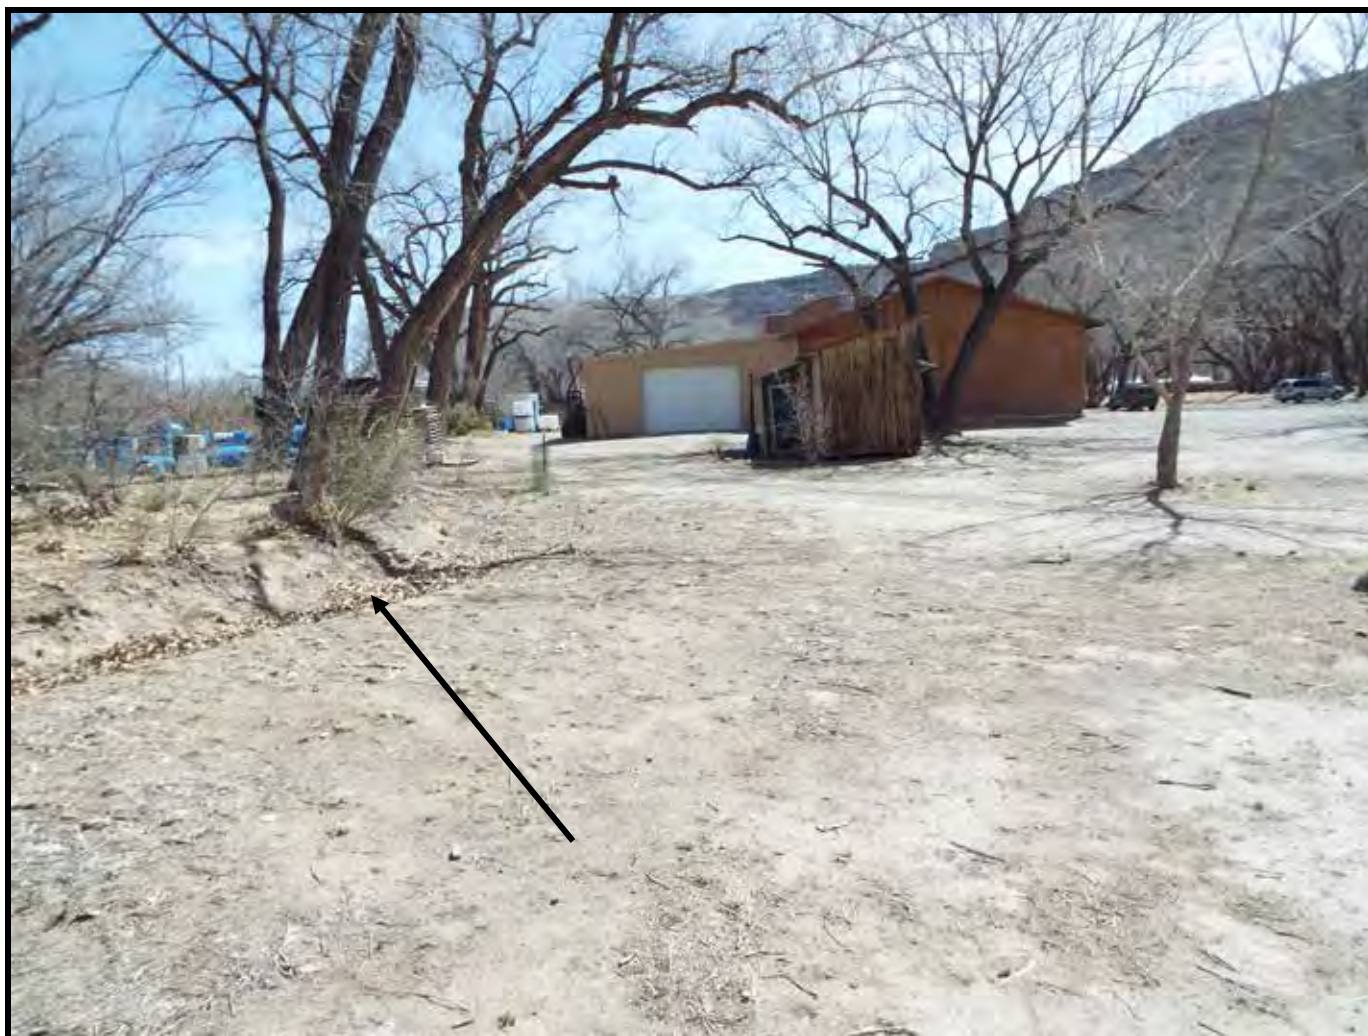
Photo # 2

As of the time of the inspection the facility did not have an NPDES MSGP active or expired permit in place for the discharges into the San Juan river. The facility is fairly level and appeared clean and orderly. A shallow ditch has been dug to allow and focus rainwater discharges, (see photo 2). The facility processed grapes, cleaned equipment, and stored materials under covered sheds and buildings. Two areas may be sources of contaminants for stormwater, (see photo's 3&4).

Photographer: Daniel Valenta	Date: April 4, 2018	Time: 1132 hours
City/County: Blanco/San Juan		
Location: 233 Highway 511, Blanco, New Mexico 87412		
Subject: Shallow ditch drains stormwater from the facility to the river.

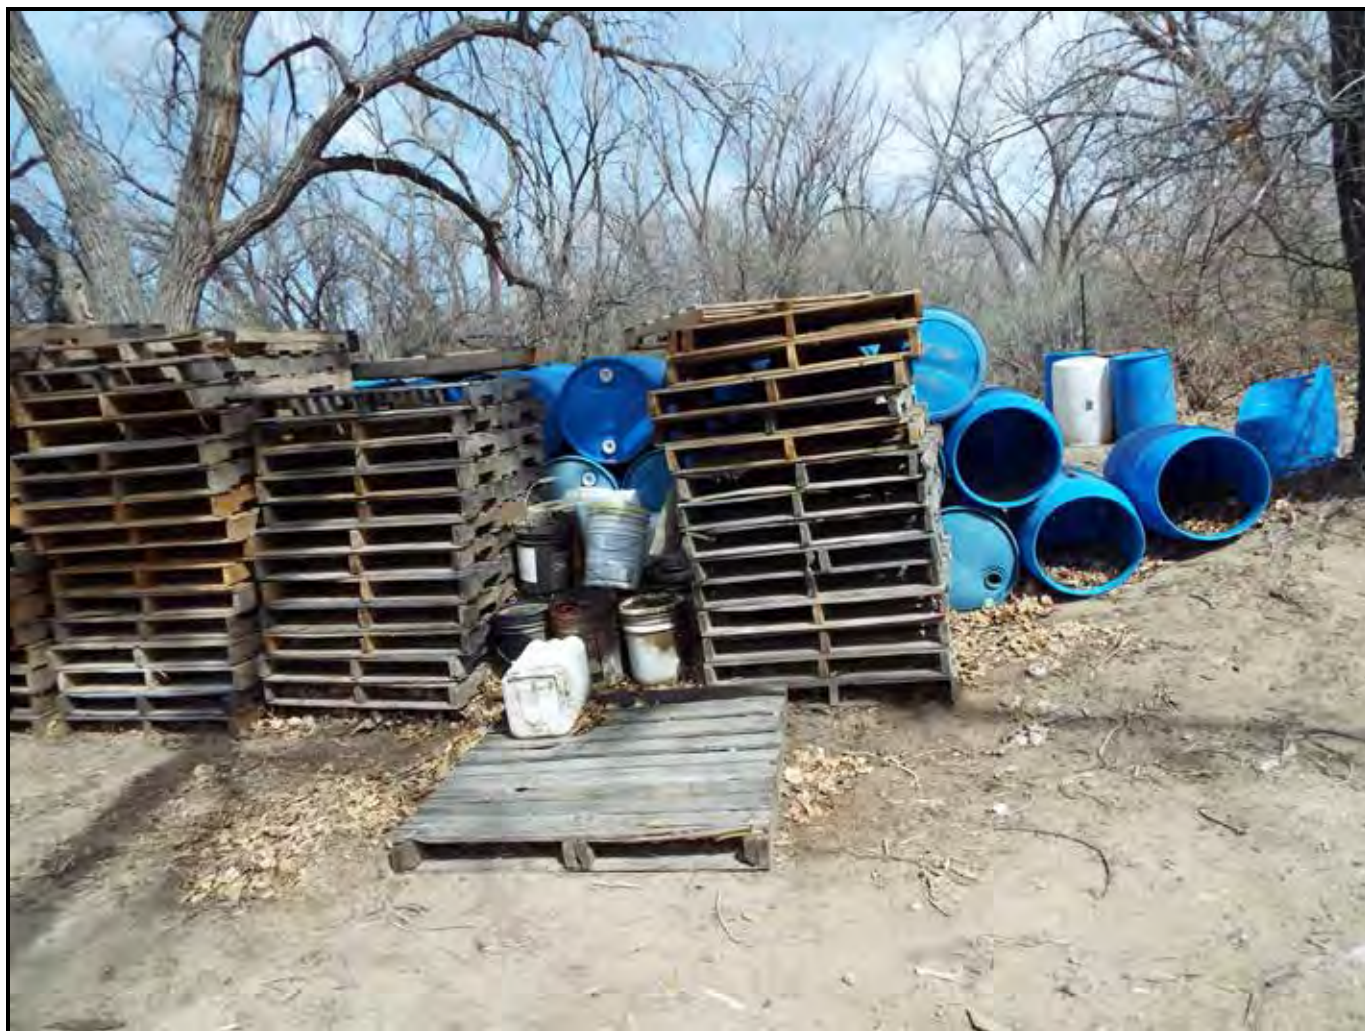
Photo # 3

Photographer: Daniel Valenta	Date: April 4, 2018	Time: 1132 hours
City/County: Blanco/San Juan		
Location: 233 Highway 511, Blanco, New Mexico 87412		
Subject: Used oil storage area is exposed to stormwater.

My waste oil will be taken to a local Jiffy Lube in Bloomfield.

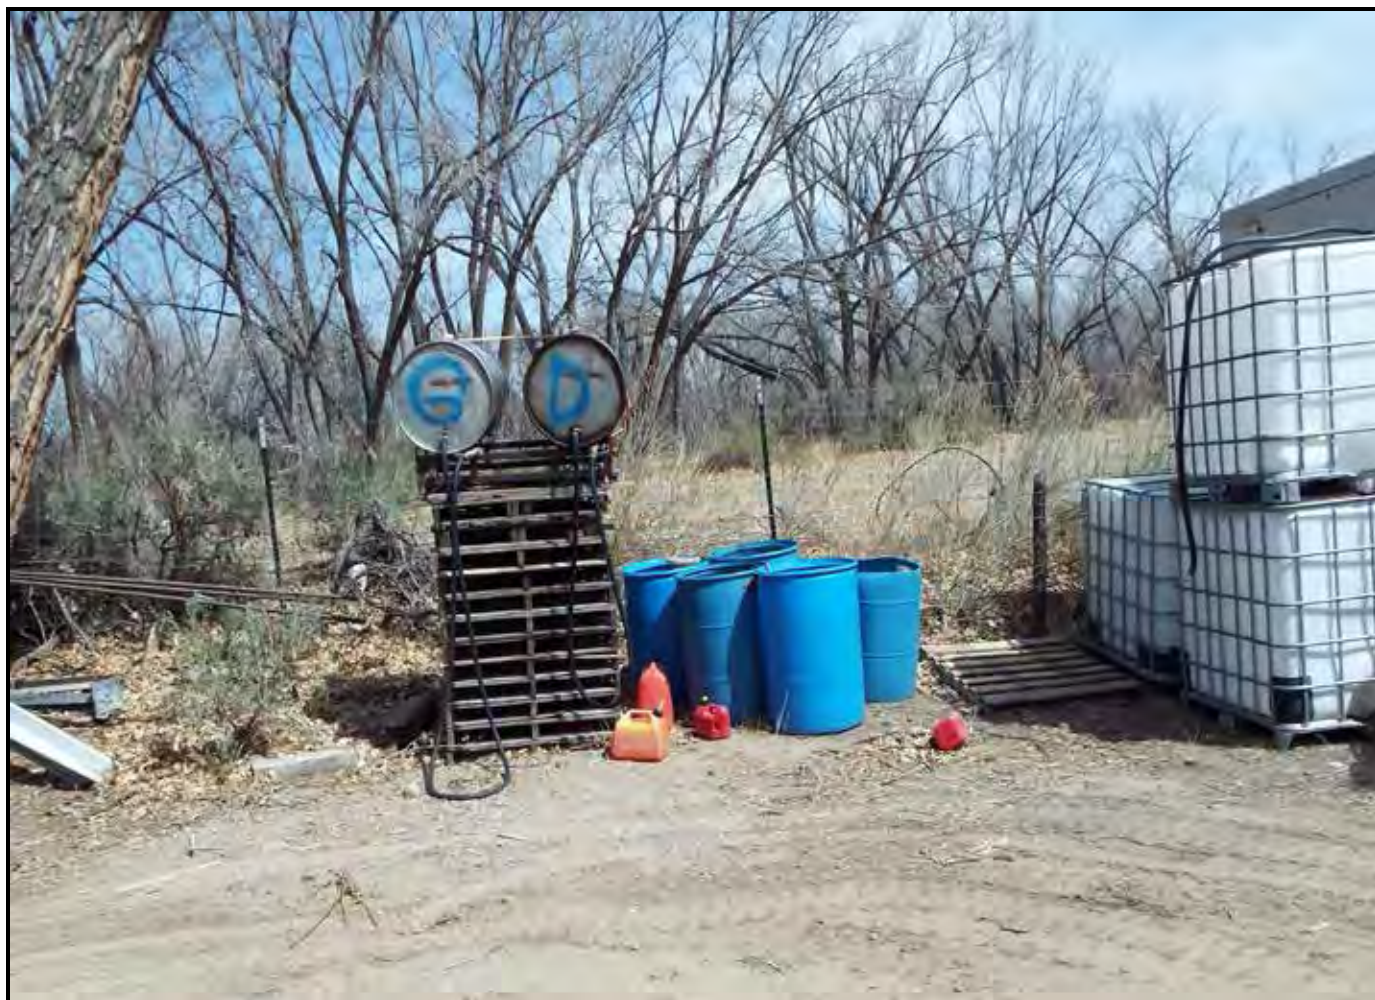
Photo # 4

Photographer: Daniel Valenta	Date: April 4, 2018	Time: 1135 hours
City/County: Blanco/San Juan		
Location: 233 Highway 511, Blanco, New Mexico 87412		
Subject: Gasoline and diesel storage area. This appears to be a fire hazard as well as a potential stormwater contamination.

As for the storm water runoff problem, my fuel storage stand (two stainless 55 gallon barrels with diesel and gasoline for tractors and mowers, etc.) I plan to move them to an undercover location out of weather exposure.
